National Environmental
Research Program

Project 2.2

Mangrove, freshwater and coastal wetlands

Damien Burrows and Norm Duke –
TropWATER, JCU

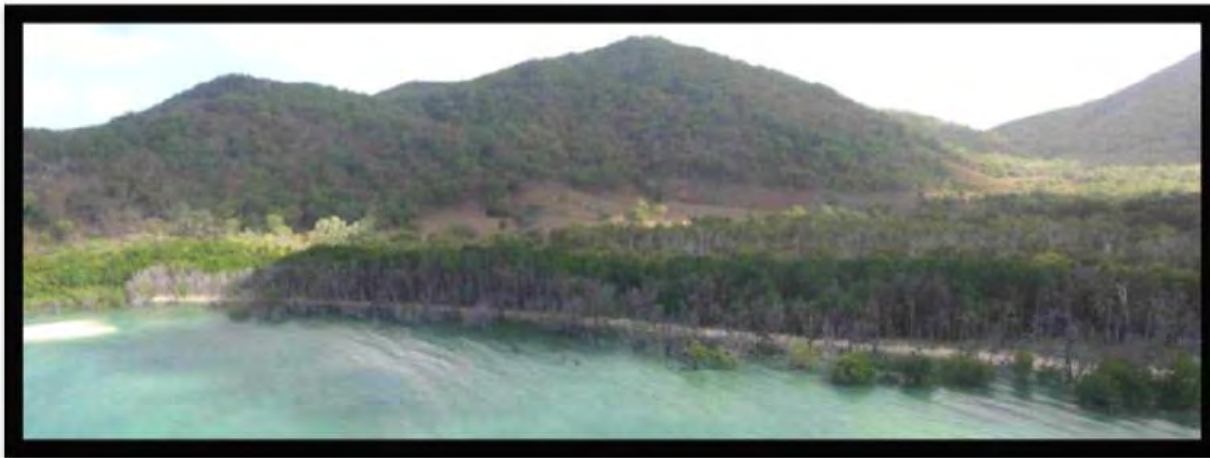
Mangrove dieback due to root burial from sand deposition caused by storm waves or storm surge, North-east Mua Is.

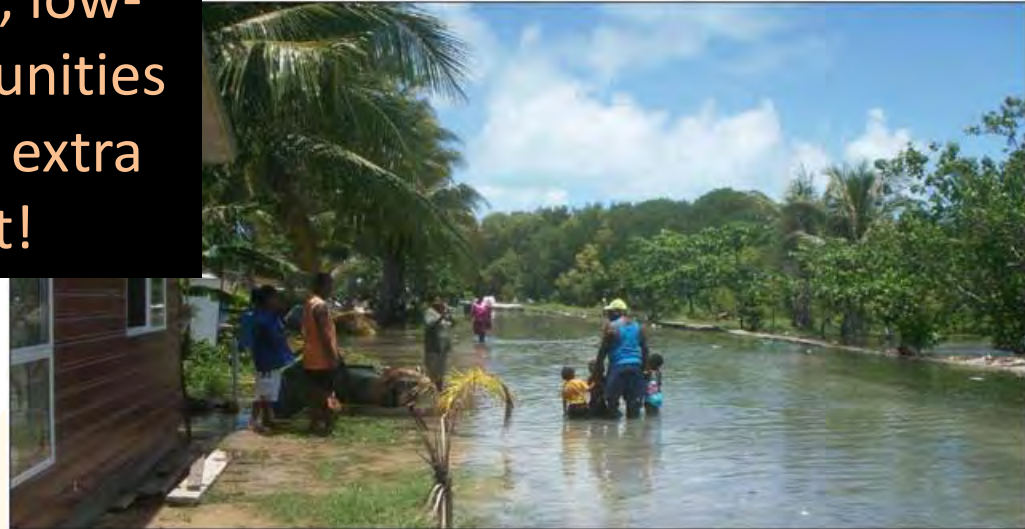
Figure 4.1. Inundation experienced at lama during king tides. Source: lama Island Council.

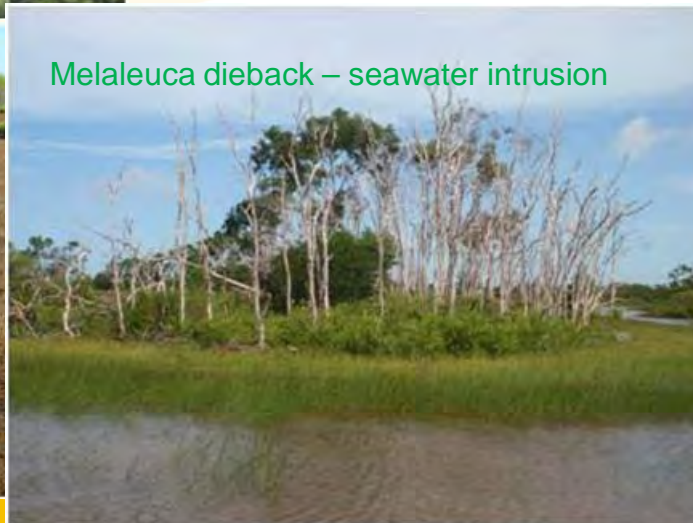
Melaleuca dieback – seawater intrusion

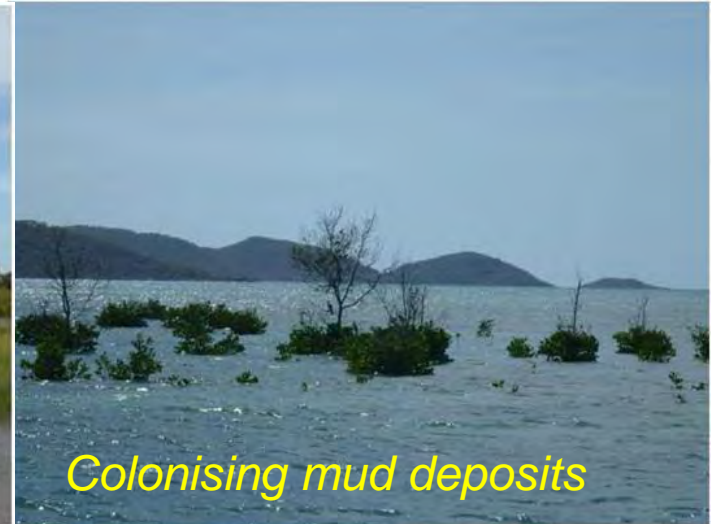
Colonising mud deposits

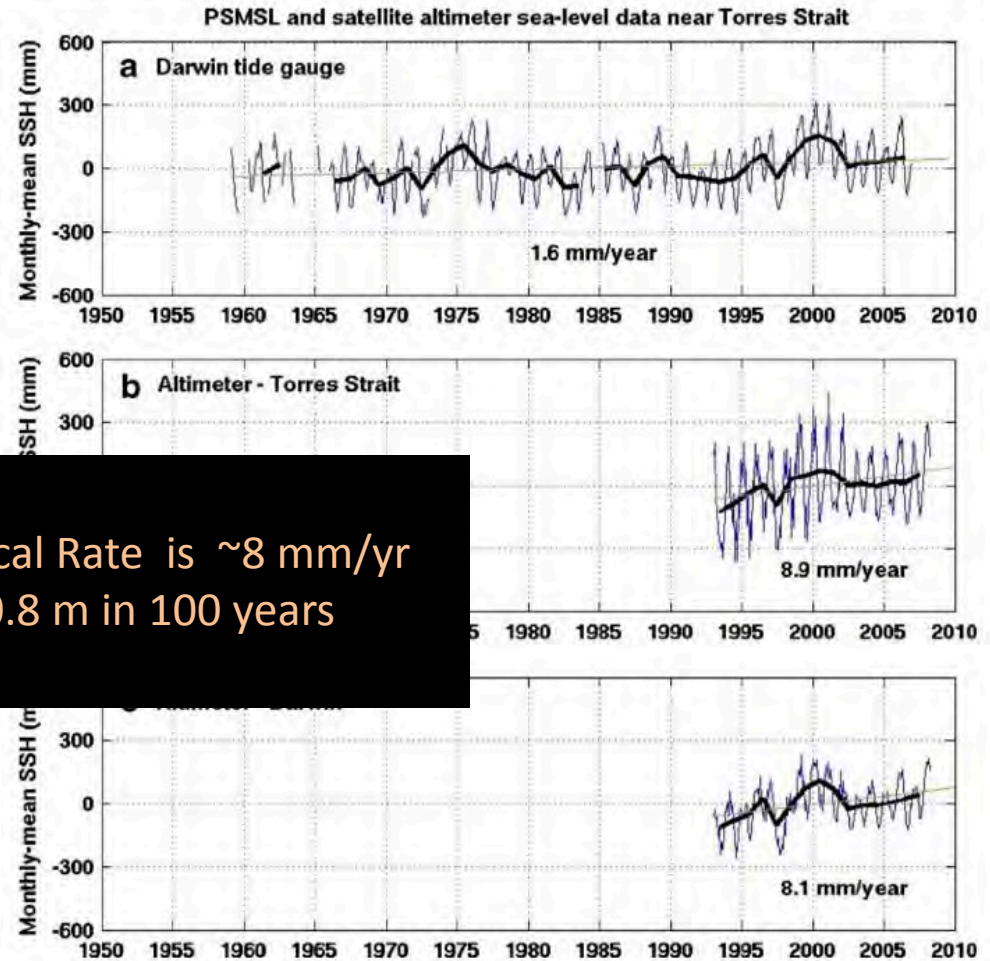
Fig. 8 Monthly averaged sea levels as measured by a tide gauge at Darwin (a), and as measured by satellite altimetry in Torres Strait (b) near Darwin (c)

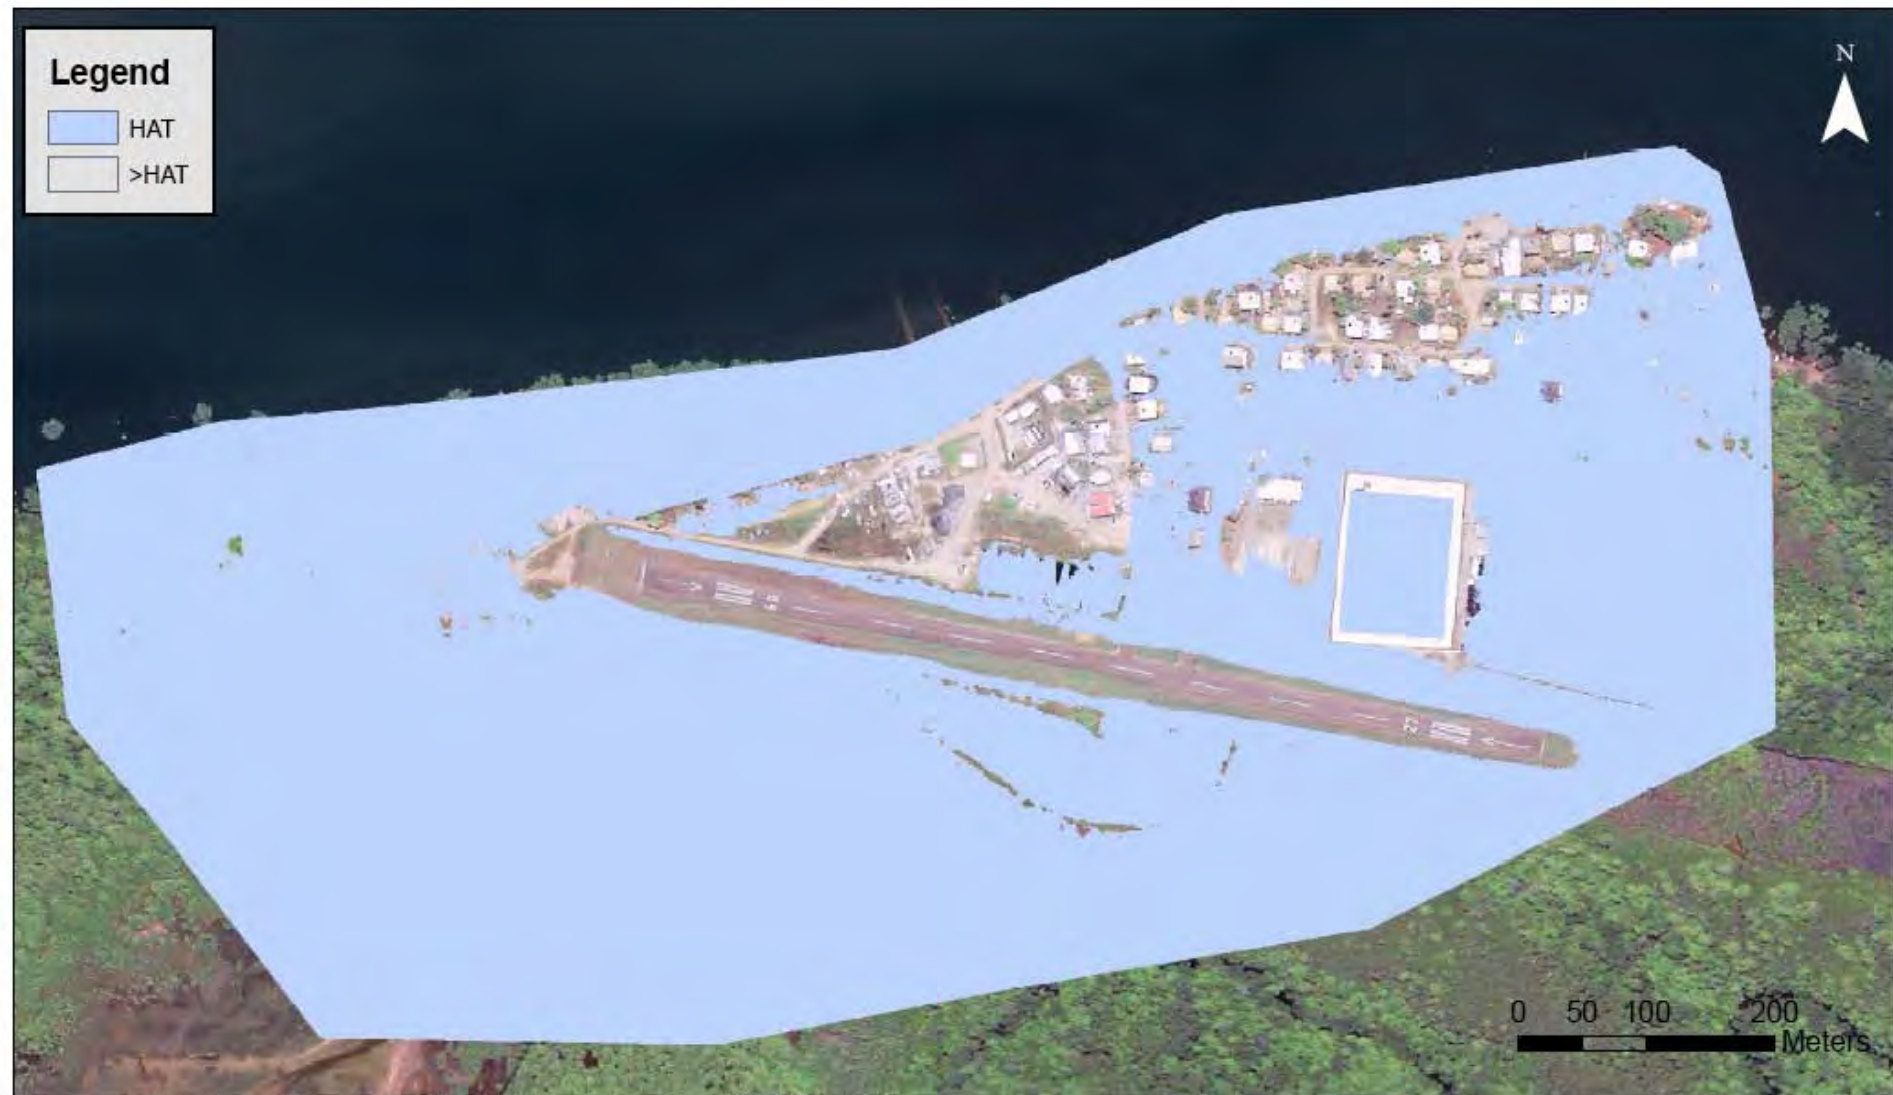
Figure 5.3a: Inundation at HAT (Highest Astronomical Tide).

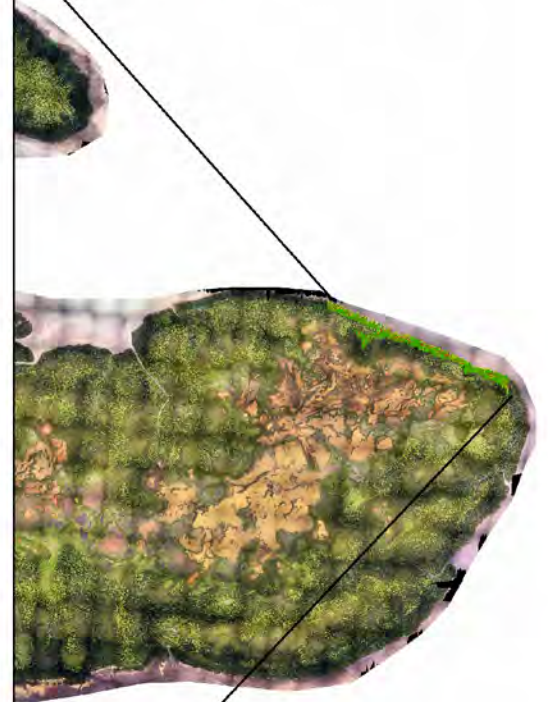
Boigu Island Mangrove Inner Fringe Condition - Example

Mangrove Condition - North-East section

Healthy = 76%
Dead/Dieback = 13.3%
Gaps = 10.2%
Water = 0.2%

Total impact = 24%

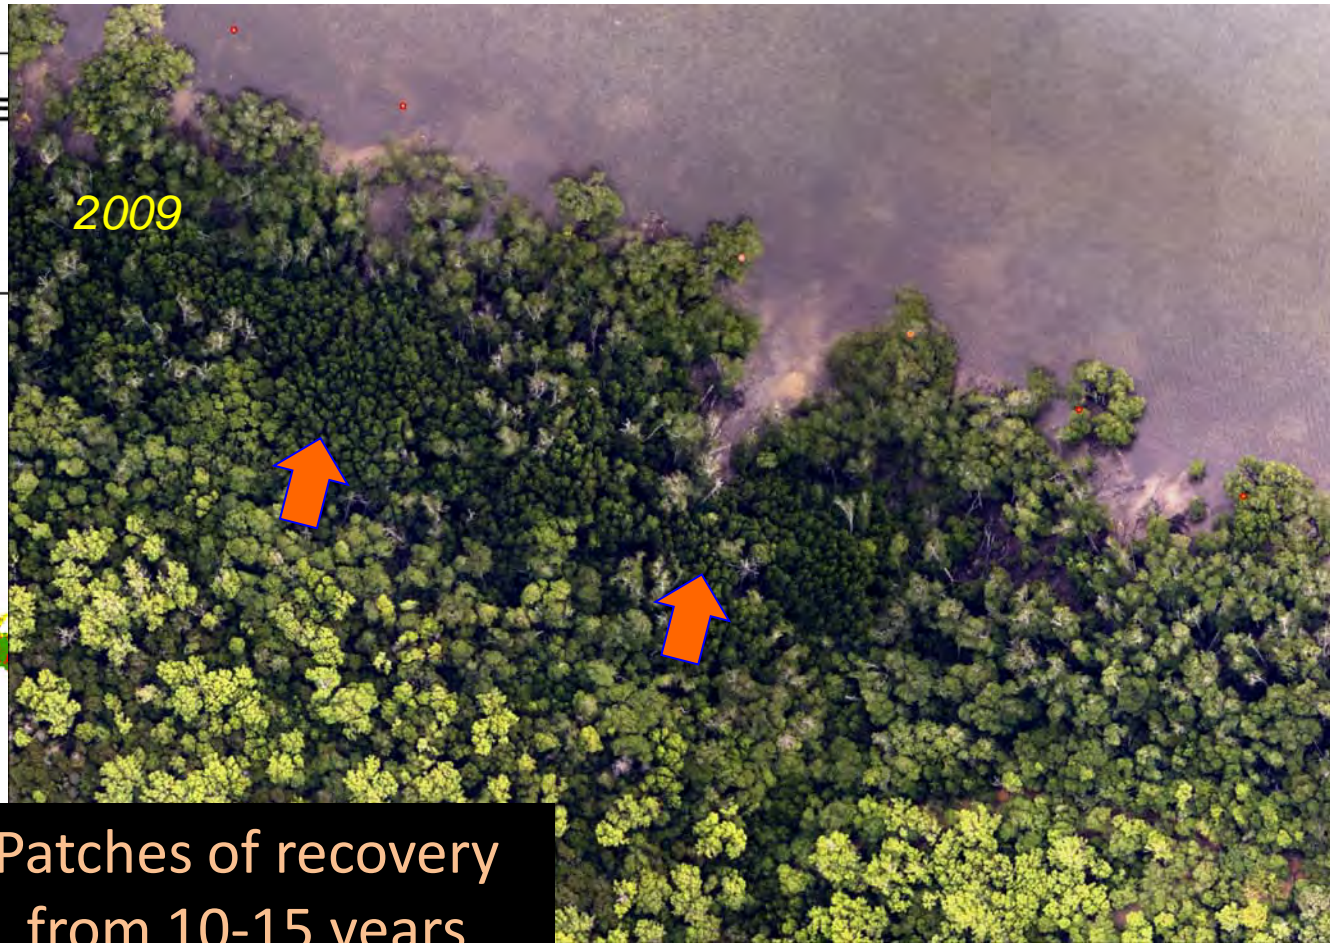
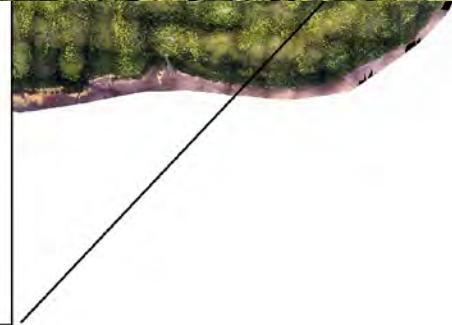
Boigu Island Mangrove Inner Fringe Condition - Example

Patches of recovery
from 10-15 years
earlier.
Apparent pulsing of
Inner Fringe
damage!?

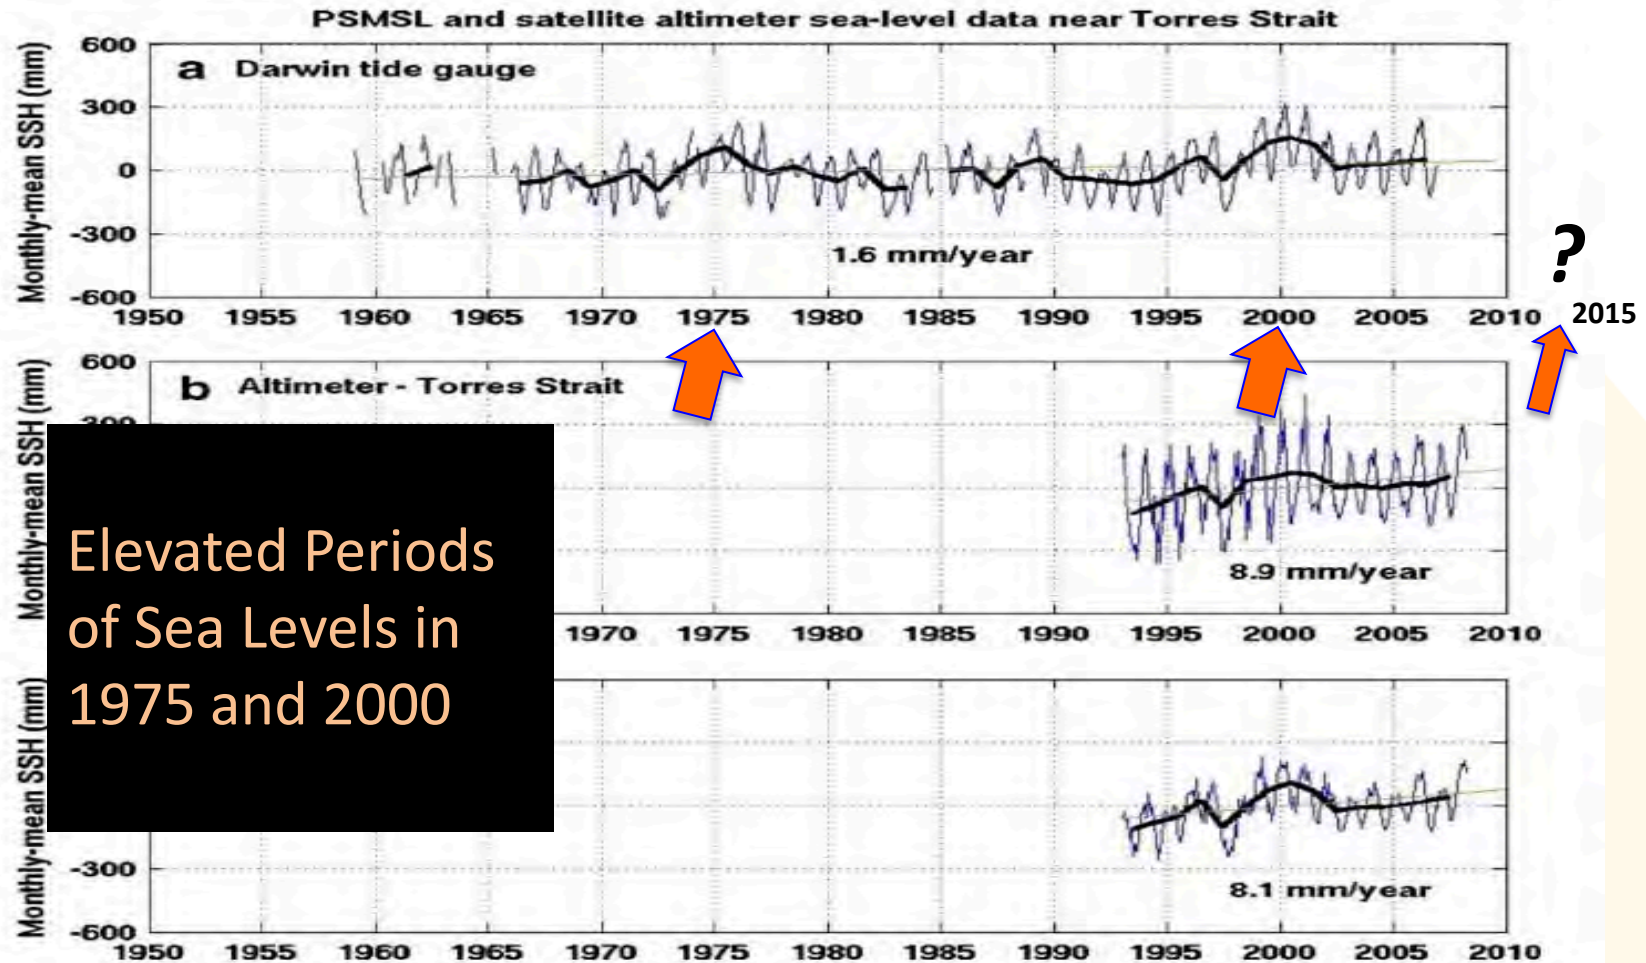
Fig. 8 Monthly averaged sea levels as measured by a tide gauge at Darwin (a), and as measured by satellite altimeter in Torres Strait (b) near Darwin (c)

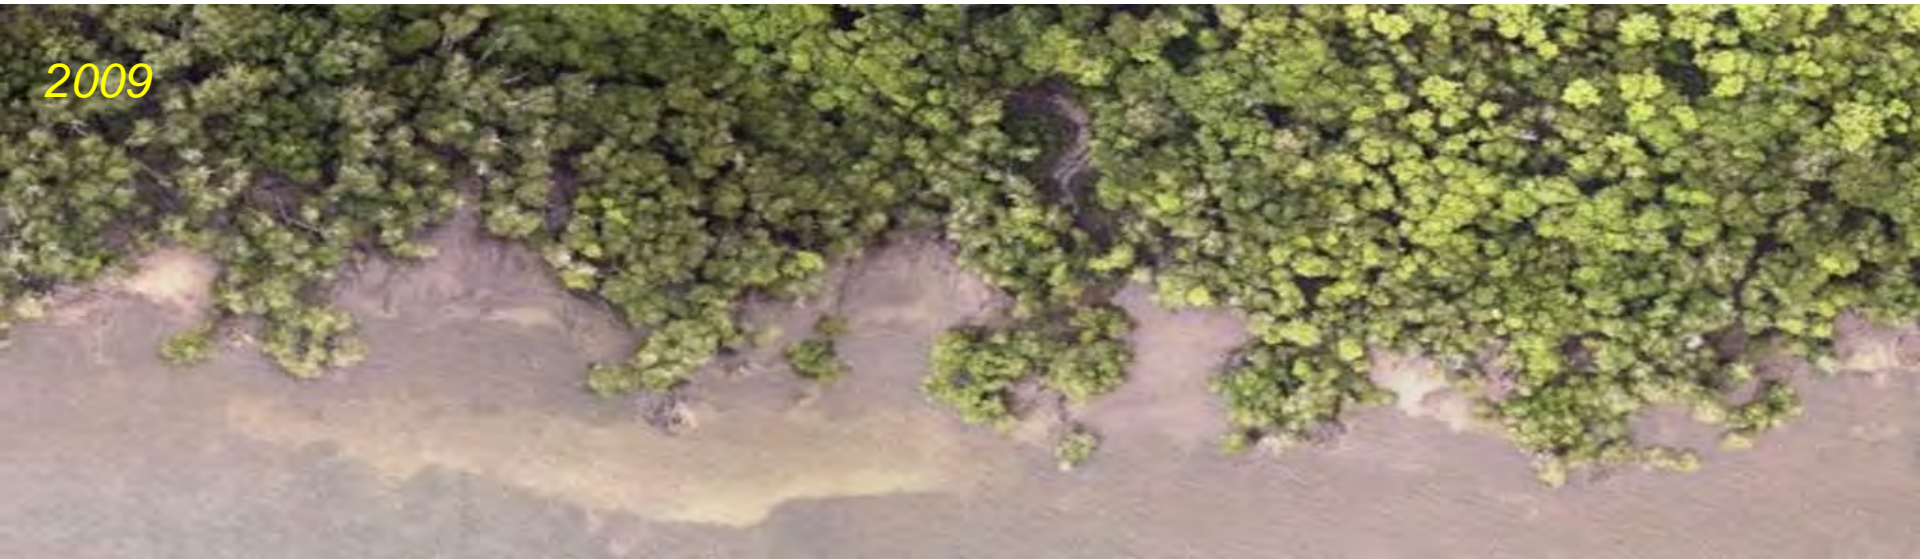
The Response of Mangroves to Sea Level Rise

Shoreline retreat – loss of low intertidal fringe trees, front edge dieback

Landward expansion – encroachment of mangroves into supra-tidal zone

Channel expansion – channel widening, scouring, greater inundation water

Inner fringe dieback – loss of inner fringe patches, gaps behind the fringe
